CUSTOMER NAME: ARMOUR-X PPF

Sample Name : ARMOUR-X Paint Protection Film

Test Item: Tensile Test
 Test Method: ASTM D638-14

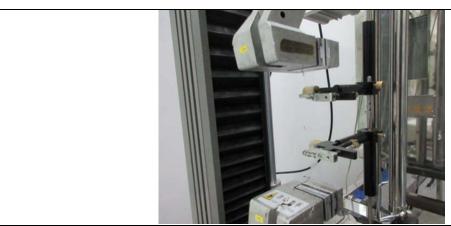
Test Photo:

During test

After test

Test Item	Test Result	
Tensile Strength	14.7MPa	
Elongation at Break	320%
